February 15, 2013

**Summary of Santa Ana Delhi Channel UAA as described in January 12, 2012 Staff Report  
(Section 5.6.3, [UAA Analysis Santa Ana-Delhi Channel](#)) and [CDM UAA Technical Report for Santa  
Ana-Delhi Channel](#)**

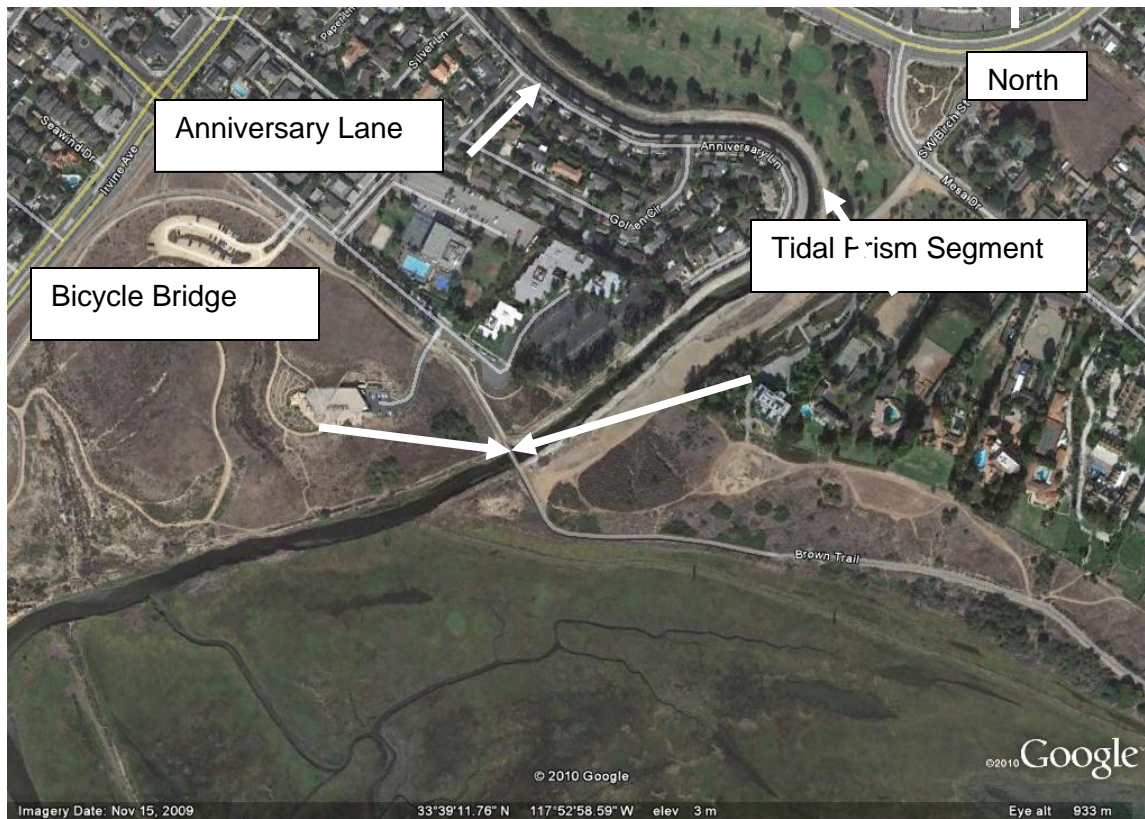
Figure SAD-2 Santa Ana-Delhi Channel, Tidal Prism Segment. (UAA Analysis SAD)

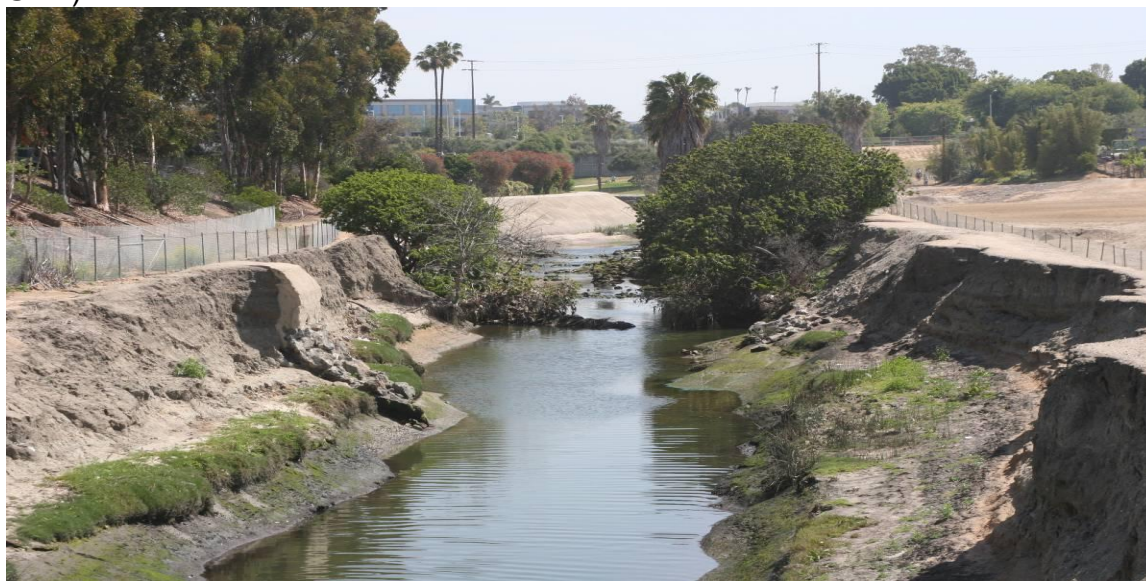
Figure SAD-3. Tidal Prism Segment, looking upstream from Bicycle Bridge. (UAA Analysis SAD). REC2 use is existing or potential, REC1 use is not attainable.

SANTA ANA-DELHI CHANNEL	REC1	REC2	40 CFR 131.10(g) Factors	
			131.10(g)(2) Low Flow	131.10(g)(4) Hydrologic Modifications
Tidal Prism	u	X	Tidal variation. At Bicycle Bridge (downstream terminus of prism): depth to 7.5 ft.; Upstream section at 1038 ft. from Bicycle Bridge: low tide depth to < 1 ft. (RB staff observation).	Earthen bottom and steep earthen sides on east side; concrete and earthen on west slope of channel. Channel length 1038 ft.
Reach 1	u	u	Depth < 2 ft. 95% of time, < 1 ft. 90% of time. Depth observed by RB Staff to be 1 ft or less and contained to low flow channel.	Concrete vertical wall channel 3.19 miles in length; includes ~ 1 mi. enclosed box culverts. Most downstream 0.25 mile earthen with concrete trapezoidal west slope.
Reach 2	u	X	6 inches or less as observed by RB staff.	0.9 mile earthen trapezoidal channel w/rip-rap; 0.55 mile concrete vertical wall channel.
<b>Representative Photographs</b>

Tidal Prism	Figure SAD-3 in Section 5.6.3 UAA Analysis SAD; Figure 2-13 of CDM UAA Technical Report SAD			
Reach 1	Figure SAD-4 in Section 5.6.3 UAA Analysis SAD; Figure 2-14, 2-15, 2-16, 2-17, 2-18, 2-19, 2-20, 2-21, 2-22 in the CDM UAA Technical Report SAD			
Reach 2	Figure SAD-5 in Section 5.6.3 UAA Analysis SAD; Figure 2-23, 2-24, 2-25 in the CDM UAA Technical Report SAD.

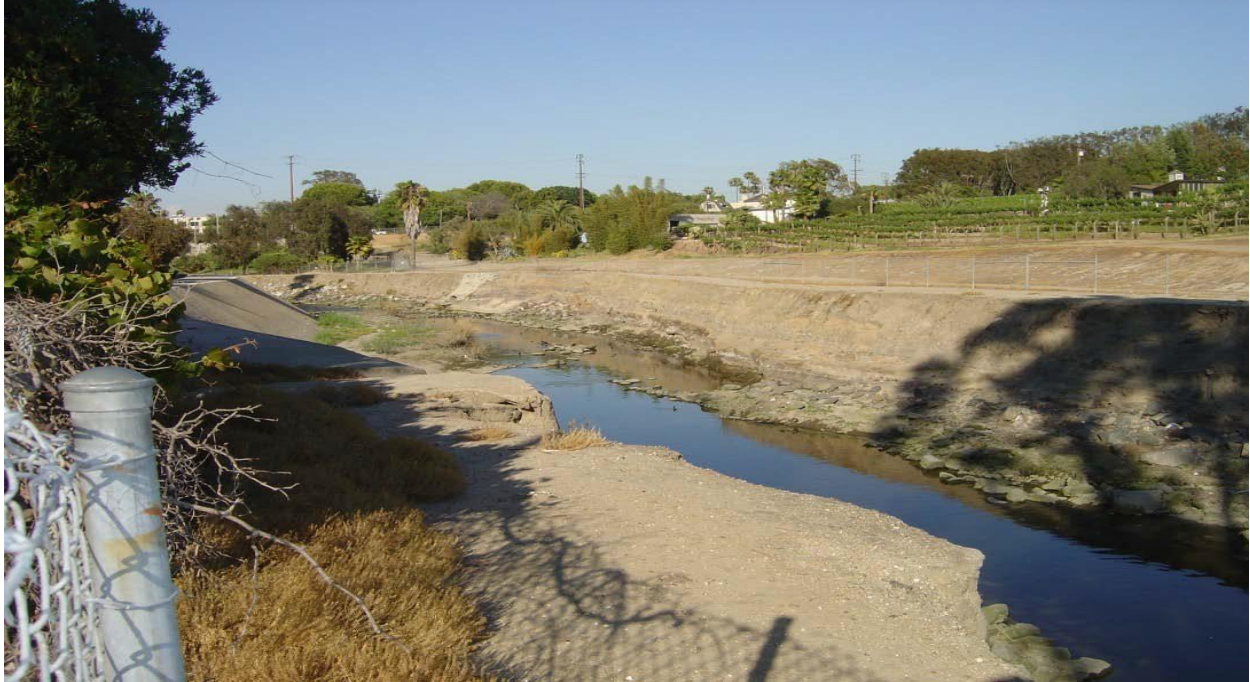
Figure 2-13 (April 2009) Tidal Prism Segment looking upstream from Bicycle Bridge. (CDM UAA Technical Report SAD)

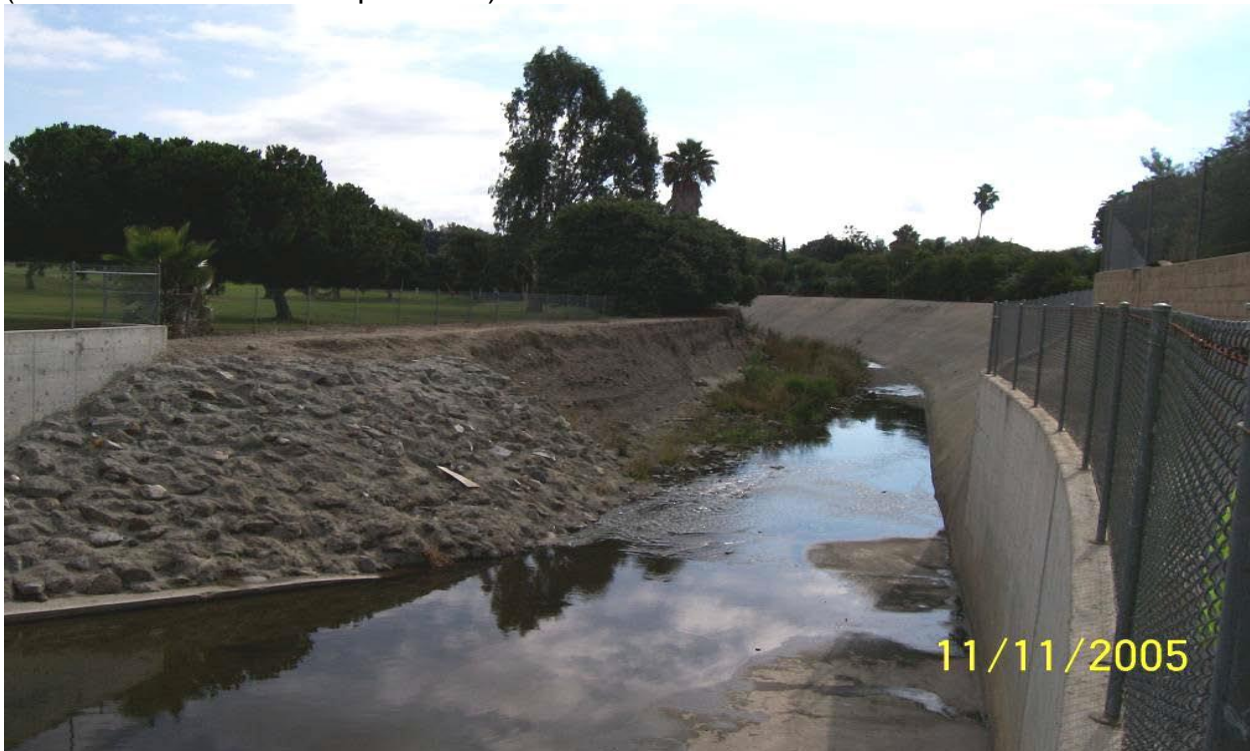
Figure 2-14 (April 2009) Reach 1 looking downstream from Mesa Ave, Newport Beach, into earthen bottom section which contains a concrete slope on west bank. The earthen section of Reach 1 is about 0.20 mile in length and is the most downstream section of Reach 1. This site was a photo REC Use Survey location. (CDM UAA Technical Report SAD)

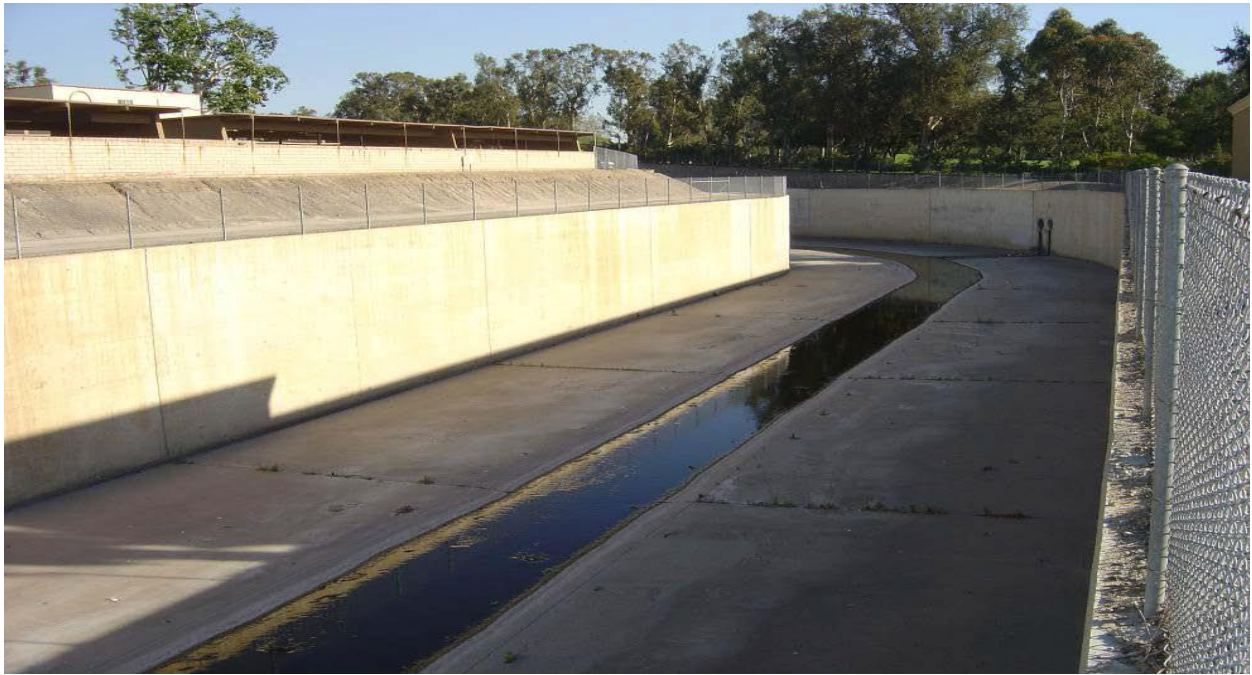
Figure 2-16. Reach 1, In the City of Costa Mesa just south of SE Bristol St. (April 2009) (CDM UAA Technical Report SAD). REC1&REC2 uses are not attainable.

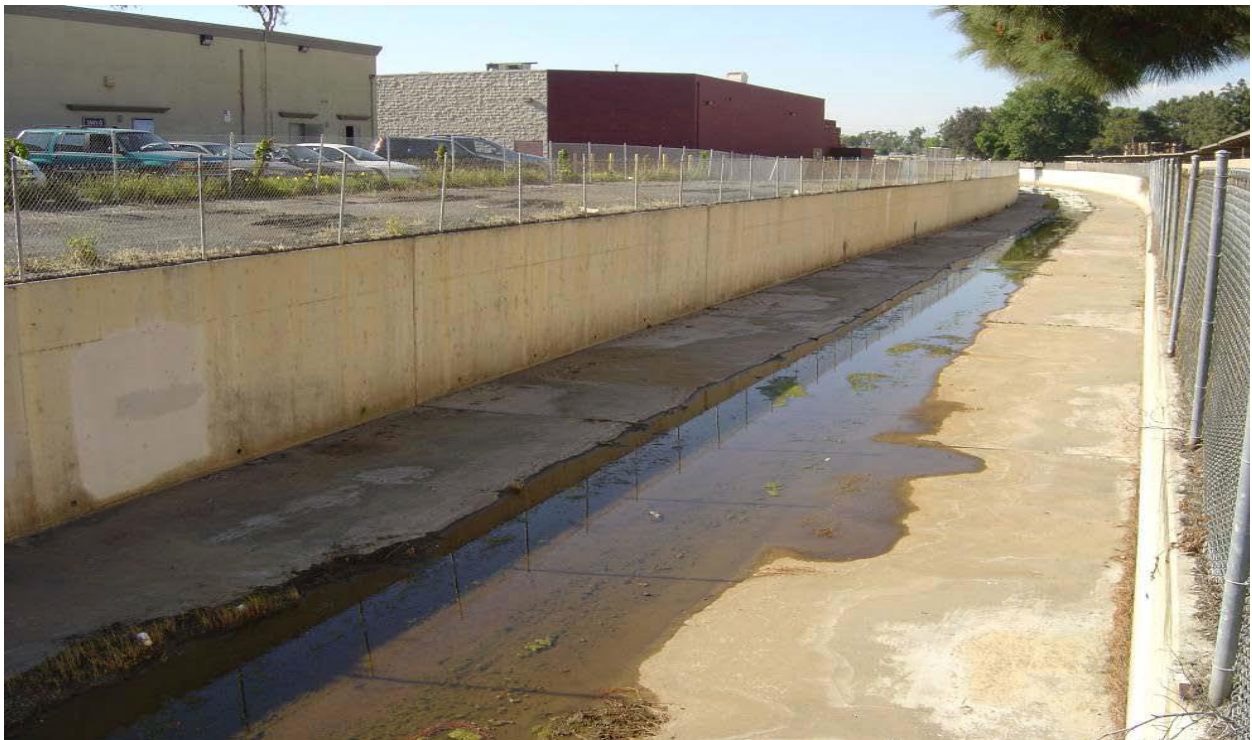
Figure 2-18. Reach 1, located in the City of Santa Ana. (April 2009) (CDM UAA Technical Report SAD).

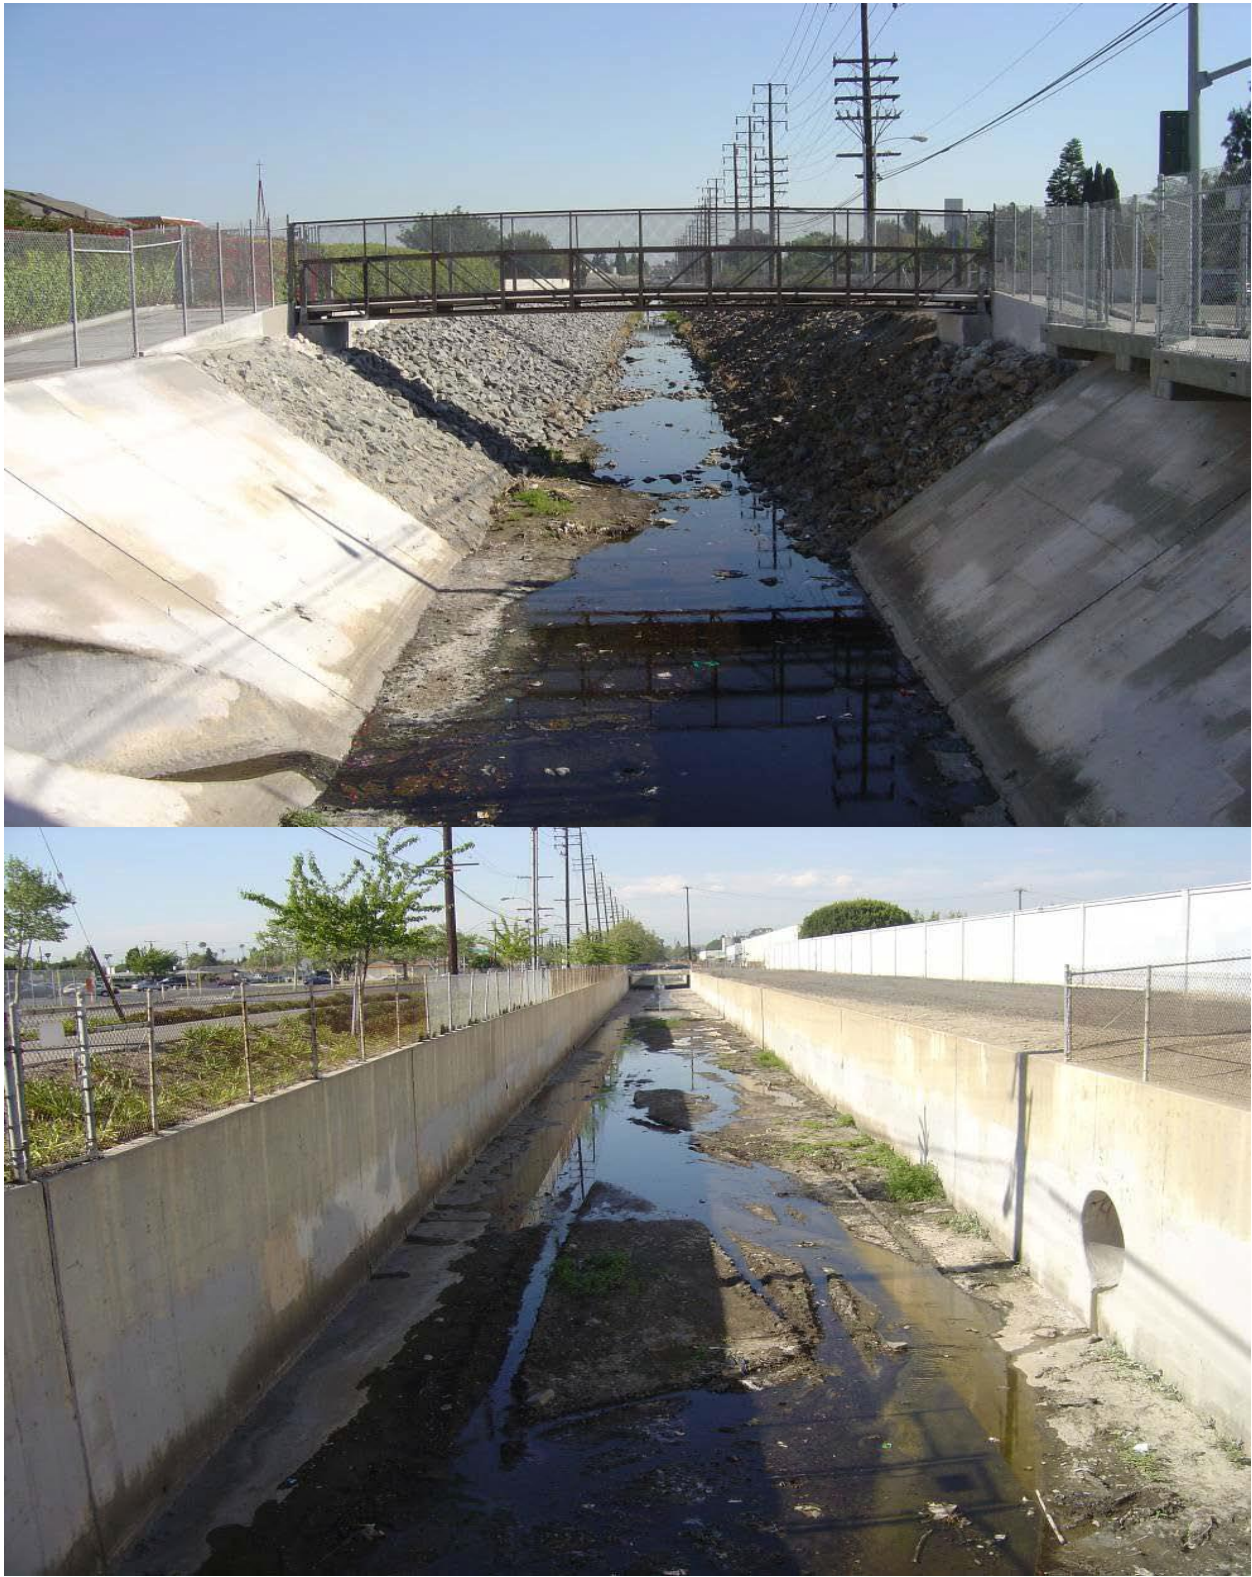
Figures 2-24 and 2-25. Reach 2, Santa Ana-Delhi Channel, rip rap and concrete box sections located in the city of Santa Ana. The rip-rap section is 0.9 mile in length while the vertical concrete section is 0.55 mile in length. (CDM UAA Technical Report SAD)

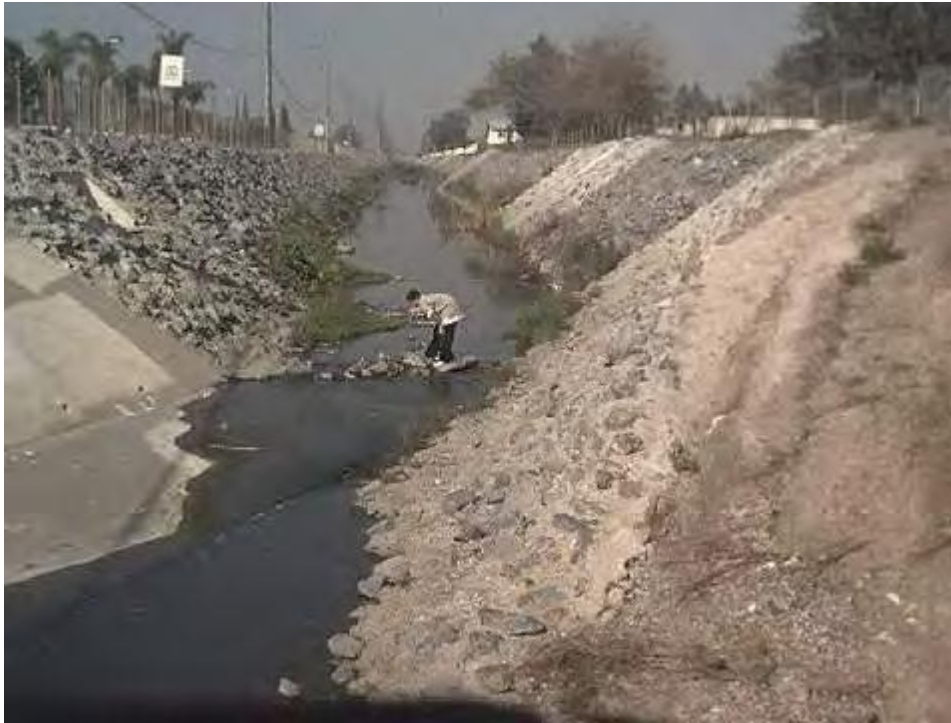
Figure SAD-15, Reach 2. Photo of activity at the Photo REC Use Survey Location on the Santa Ana-Delhi Channel at Sunflower Avenue in the City of Santa Ana. (In the January 12, 2012 Staff Report, Figure SAD-15 was mislabeled as being at Mesa Drive.) This is the only image out of almost 21,000 photos taken at this location during the digital camera REC survey of anyone close to the water. REC2 use is considered existing or potential, REC1 use is considered not attainable. (UAA Analysis SAD)

**Notes on Table SAD-4:** Observations of individuals walking/bicycling or sitting were of individuals not in contact with the water. A possible exception was one observation at Sunflower Avenue (see Figure SAD-15, below, which shows a young adult standing in the channel; it is not clear whether there was any hand contact with water).

**Conclusion:** No photographic evidence of REC1 activity within the Santa Ana-Delhi Channel; very limited REC2 activity that did not entail physical contact with the water (w/possible exception shown in Fig. SAD-15).
